House plan analysis Hallum-Hellema (Friesland)

Postma, D. (2020). *House plan analysis Hallum-Hellema (Friesland): A three-dimensional reconsideration of the early medieval turf buildings*. (57 ed.) (Grondsporen; No. 57). Groninger Instituut voor Archeologie, Rijksuniversiteit Groningen.

A three-dimensional reconsideration of the early medieval turf buildings

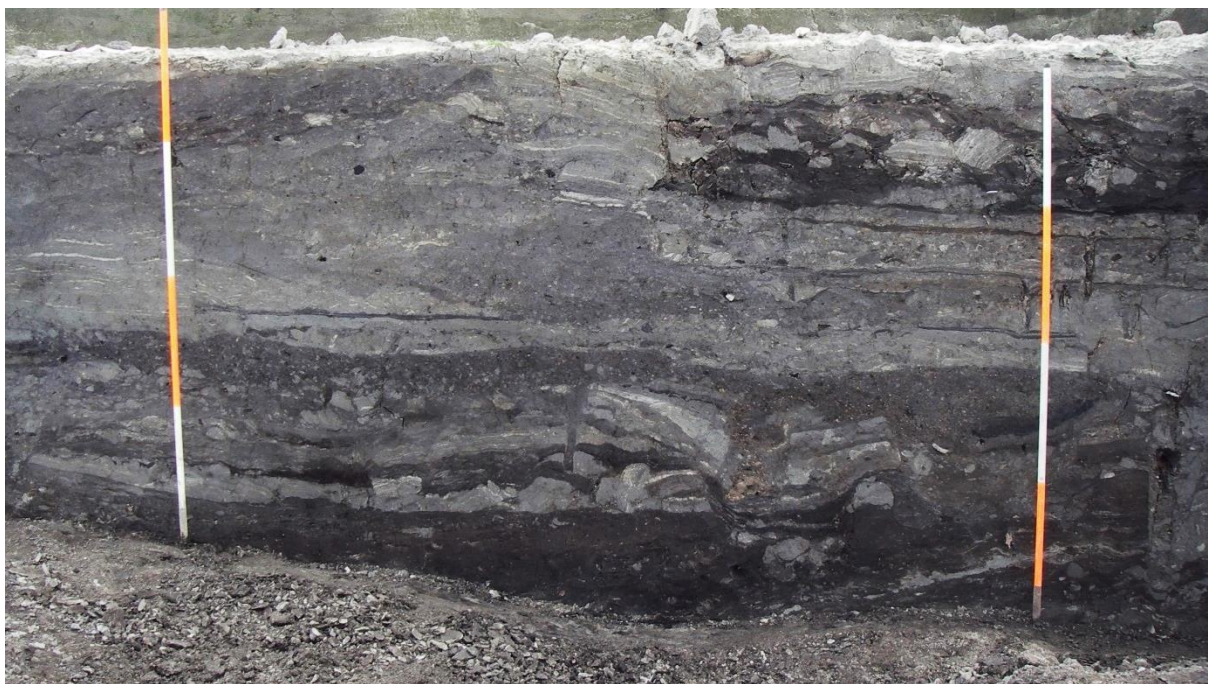
Fig. 1. East profile showing sections through various turf-walled buildings.

The housing development in Hallum, on the former site of the Hellema biscuit factory, required part of the town's archaeological deposits to be preserved *ex situ*, or in other words to be carefully removed and recorded by means of archaeological excavation. In total, three successive excavations were conducted by Archaeological Research & Consultancy (ARC), including a test trench in March, a full-scale excavation from May to August and a brief complementary excavation in September 2017. As will be explained in more detail in chapter 1, *terps* are complex sites to record and interpret under the best of circumstances, and since the circumstances in Hallum-Hellema were not ideal the project's final report could not explore the full potential of the site's well-preserved building remains (Tuinstra *et al.*, 2011); Fig. 1).

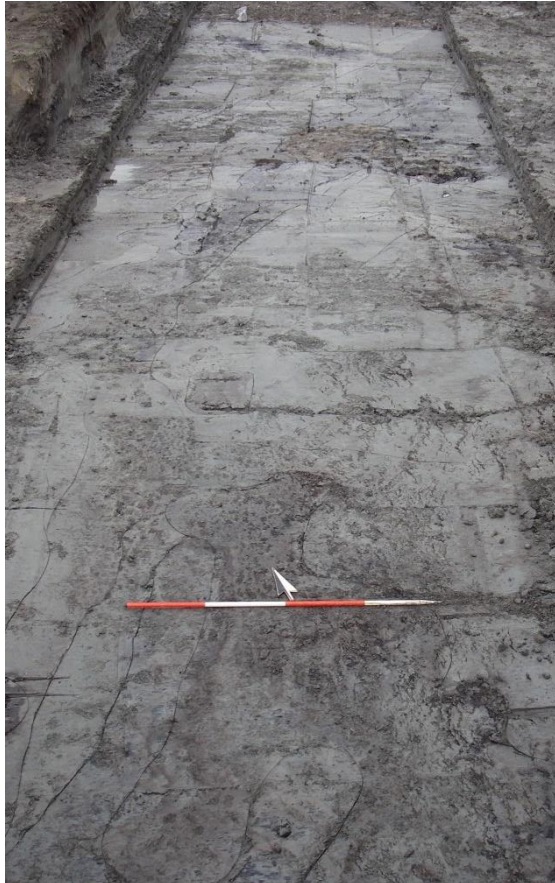
Fig. 4. Example of a hard-to-read excavation level.

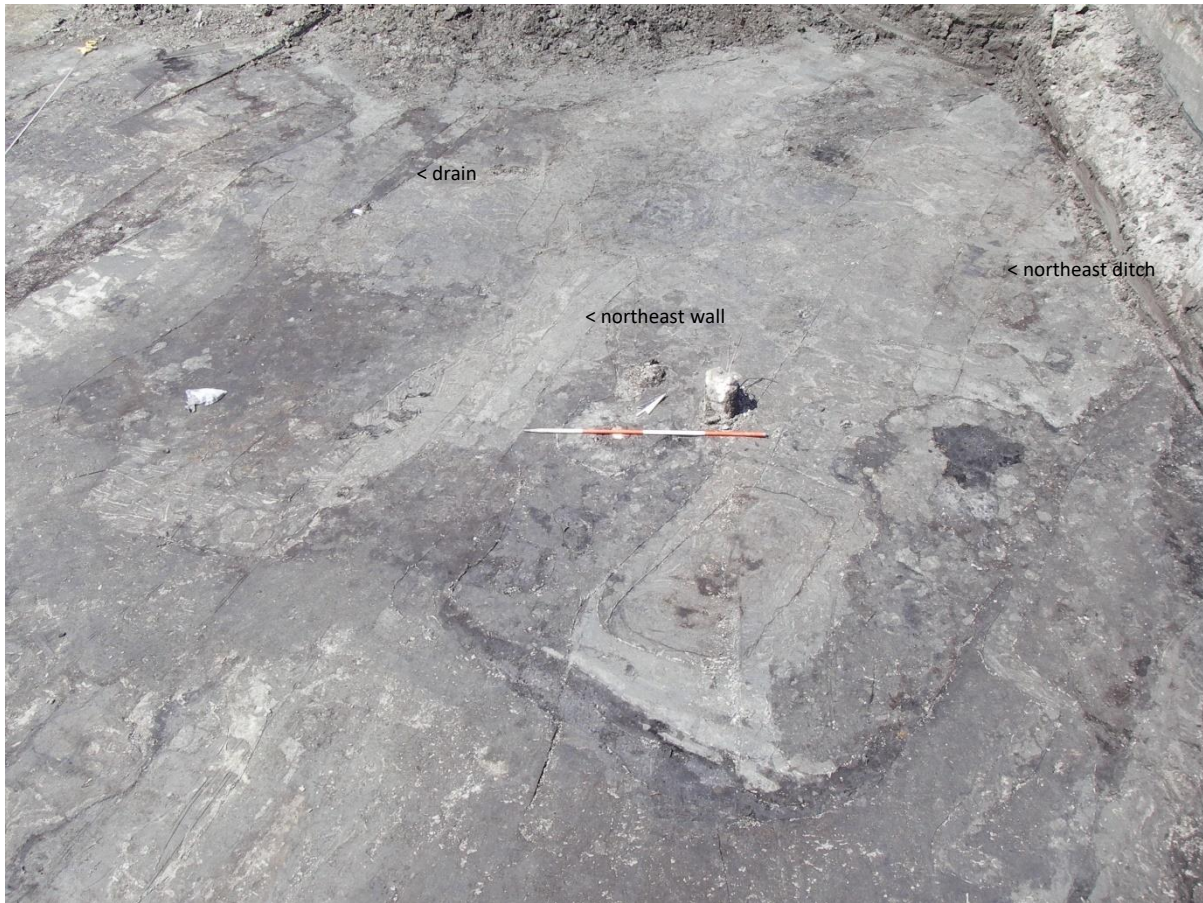
Fig. STR2-1. Trench 6, level 8, showing northeast wall (T6 L8 F337), boundary ditch (T6 L8 371/373) and presumed byre drain (T6 L8 F346).

2. Use of space: no indications for an interior division. A presumable byre drain (T6 L8 F346, Fig. STR2-1) was found in the lower northwest end of the building, ca 1.5 m from the wall face, giving an asymmetrical byre interior layout.
A small patch of burnt material (T6 L8 F333, Fig. STR2-4) undercuts the northwest wall. The east profile shows a burn layer (F1296, Fig. STR2-2) in the higher southeast end of the building, possibly indicating a work area.
Suggested use: byre with work area.

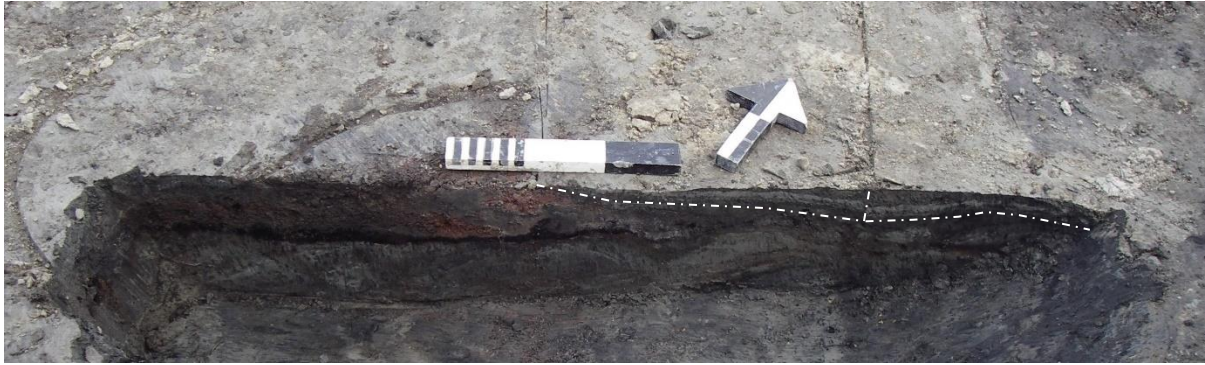
Fig. STR2-4. Section of northeast wall (T6 L8 F337) and burnt patch (T6 L8 F333).

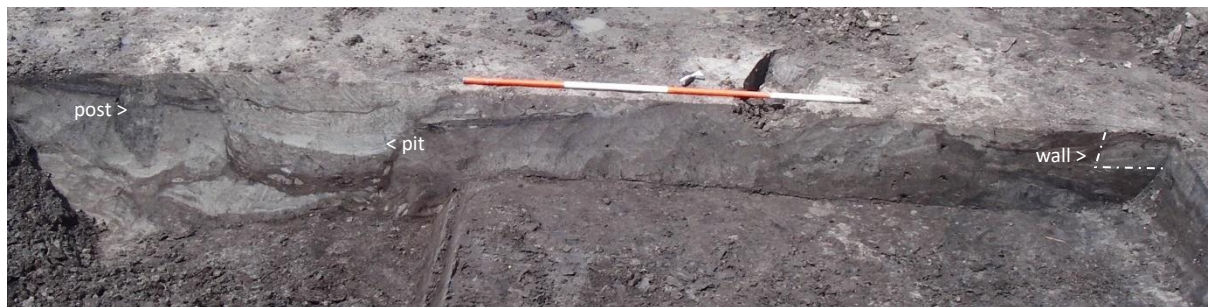
Fig. STR2-5. Section through northeast yard, with pit (T6 L8 F360) and post (T6 L8 F354), cutting into southwest wall of structure 3 (right; T6 L8 F281).

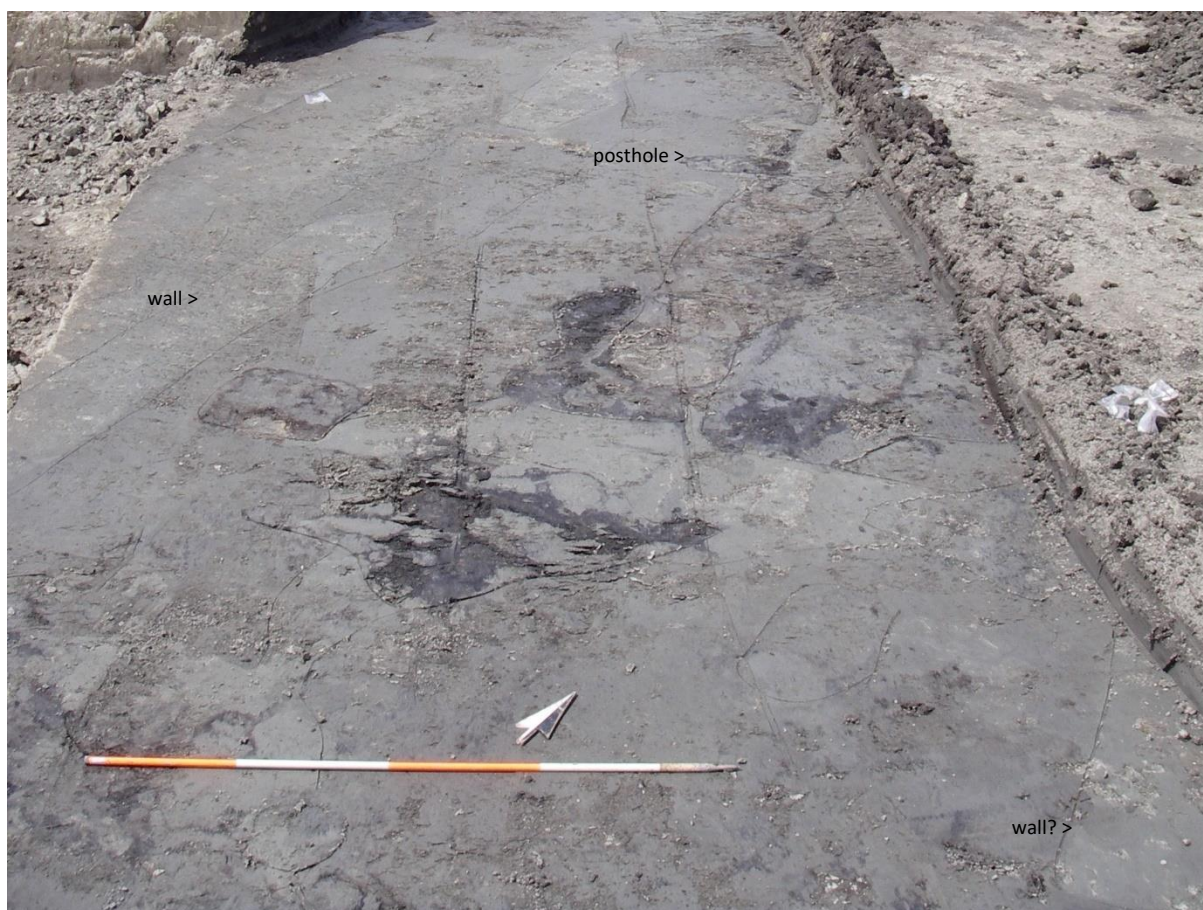
Fig. STR5-1. Trench 5, level 7, showing southwest wall (T5 L7 F237), northeast wall (T5 L7 F254) and post pit (T5 L7 F262).

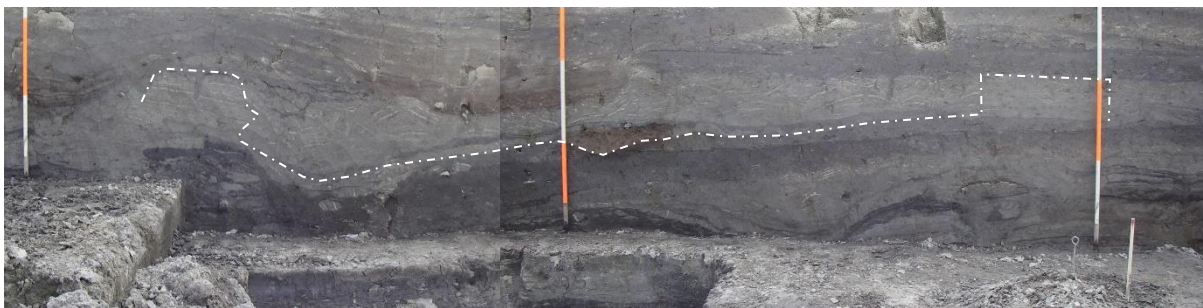
Fig. STR6-1. East profile, showing approximate section through structure 6.

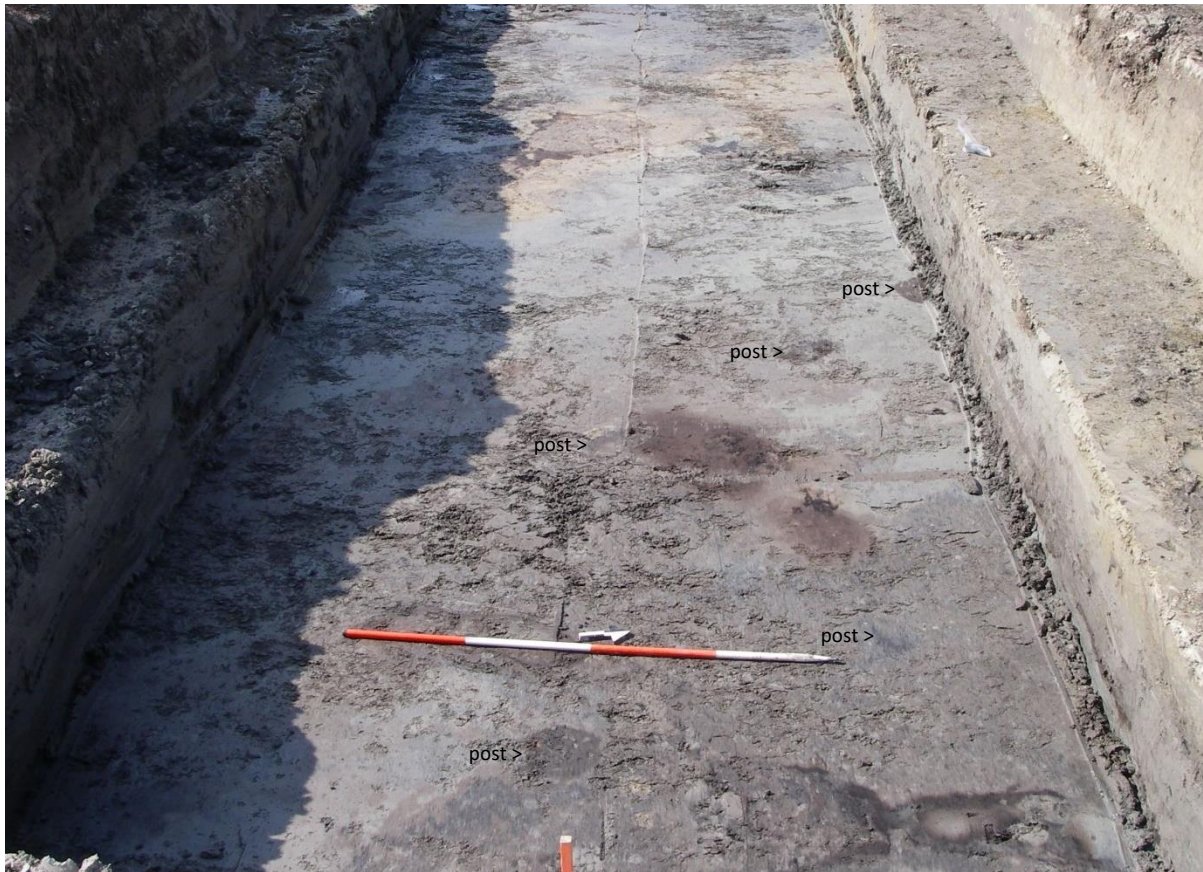
Fig. STR7-1. Trench 1, level 5, showing five postholes in two parallel rows.

1. Typology: primary architectural features are five postholes (T1 L5 F111, F115, F119 and F121-F122) recorded in the northwest end and a probable sixth posthole to the southeast, recorded in two levels (T5 L5 F209 and T5 L7 F209).
The lower excavation level shows three longitudinal features, here interpreted as wall ditches – southeast short wall (T5 L7 F285), recorded as foundation ditch during excavation; unconfirmed interior partition (T5 L7 F295), originally recorded as heightening layer; and northeast long wall (T6 L7 F232), initially recorded as unspecified ditch. No cross sections are available to confirm the interpretation of these wall features, but the unrecorded southwest long wall can be discerned in the north profile (Fig. STR7-2).
Two apparent postholes (T5 L7 F283-284) in line with the southeast wall were recorded as (backfill) turves during excavation but appear similar in plan as the door posts of structure 5. The presumed door posts of structure 7 stood ca 80 cm apart.

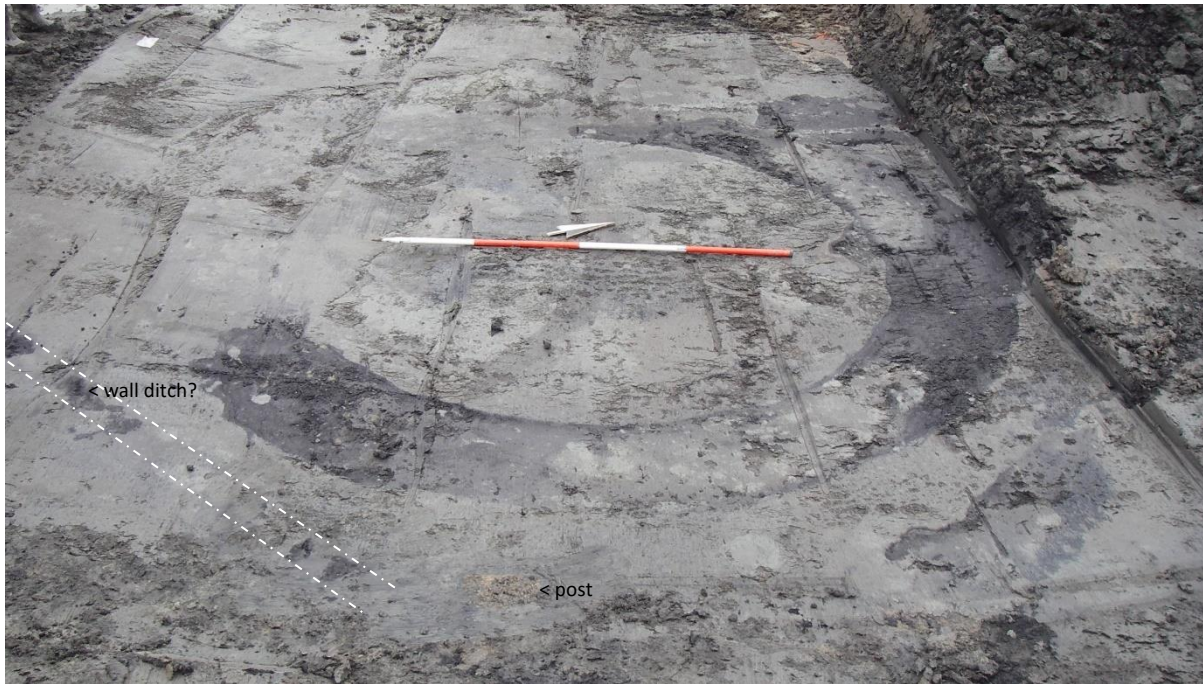
Fig. STR8-1. Trench 6, level 4, showing part of northeast wall ditch (T6 L4 F119) and probable posthole (T6 L4 F137) along its interior side. Earlier ring ditch (T6 L4 F112) clearly recognisable in the middle of the photograph.

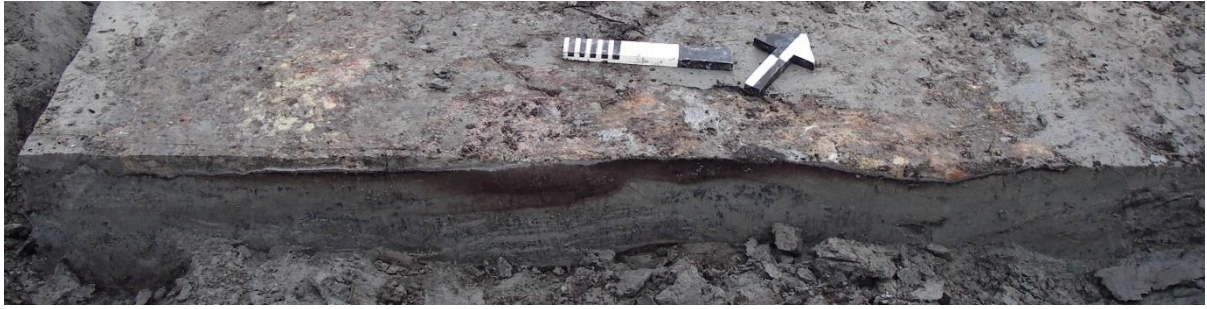
Fig. STR8-4. Section of burn layer (T6 L4 F120) in front of southwest long wall (T6 L4 F96) sectioned along its length to the left.

2. Use of space: the two rooms at the southeast end were 5.2 m and 7.1 m long internally, the latter including a layer of burnt material (T6 L4 F120; Fig. STR8-4), possibly indicating a fireplace. No evidence of a byre area can be discerned, although little of the lower end of the building was excavated (see also structure 16). Suggested use: dwelling, presumably without byre area – with central hall?

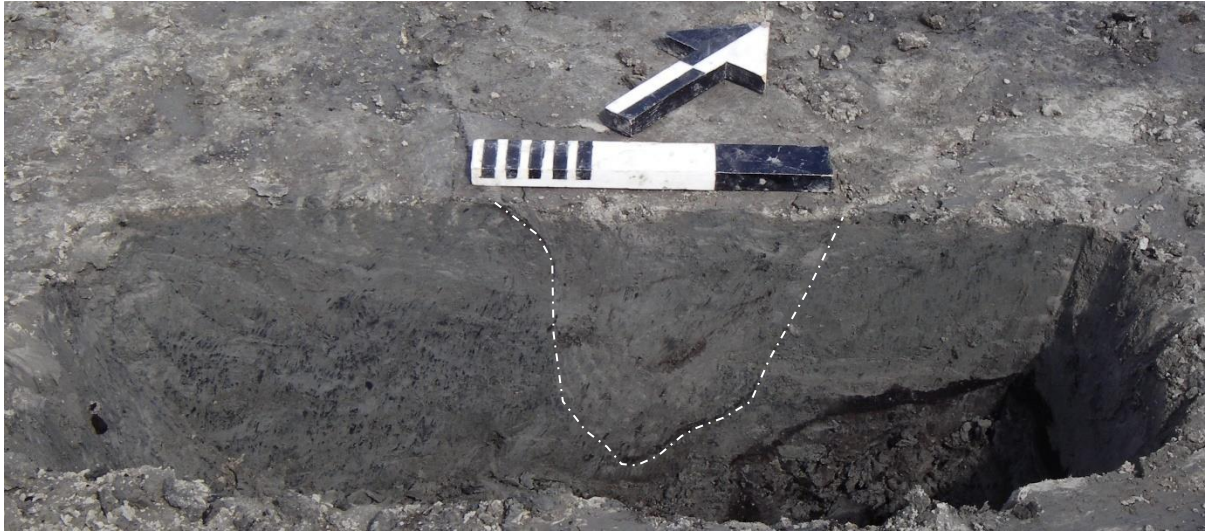
Fig. STR8-5. Section of southwest boundary ditch (T5 L5 F204)

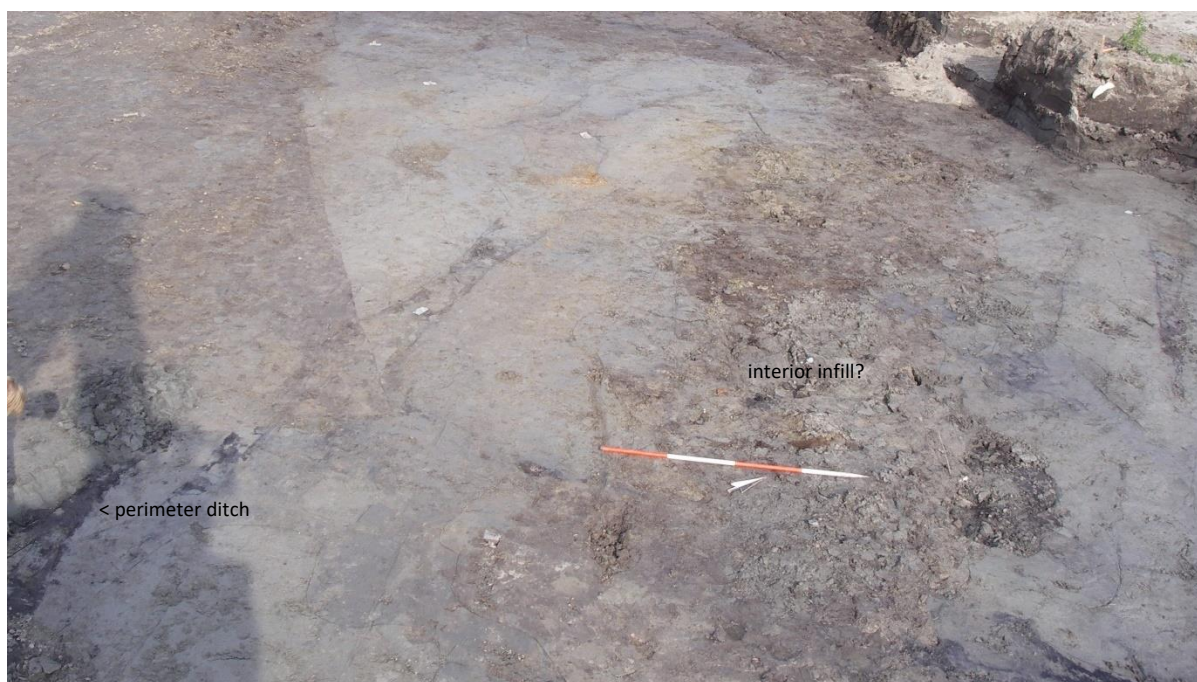
Fig. STR9-3. Trench 6, level 3, showing loose interior fill (presumably; T6 L3 F2) and curved curtilage ditch (T6 L3 42).

2. Use of space: no evidence of internal division is recognisable. A large loose-textured feature in the building's interior was noted in three excavation levels (T6 L2-4 F2); it was recorded as 'recent' but its layered and multi-coloured appearance in the photographs looks like that of floor and infill layers noted in other buildings. The feature's apparent depth (> 60 cm) is not like the more regularly shaped sunken floor in structure 17, however; it appears to concern an interior deepened not by design but through intensive use and periodic cleaning out. Similar deepening has been noted in byre areas of some Odoorn-C-type buildings (Waterbolk, 2009, p. 91), although there are no further indications that structure 9 may have been used as a byre. The most likely use of the building is suggested by the interpretation of its structural design and curtilage (see below), all of which are most reminiscent of a chapel of church building.

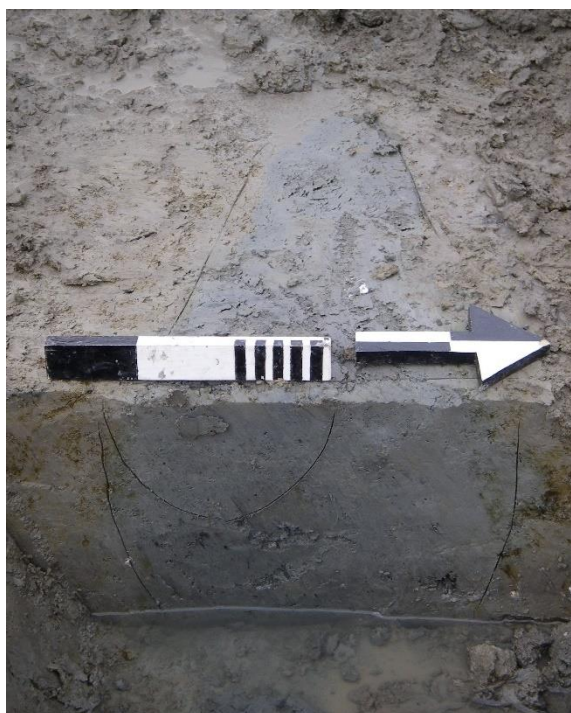
Fig. STR9-4. Section of presumed post pit (T1 L2 F19).

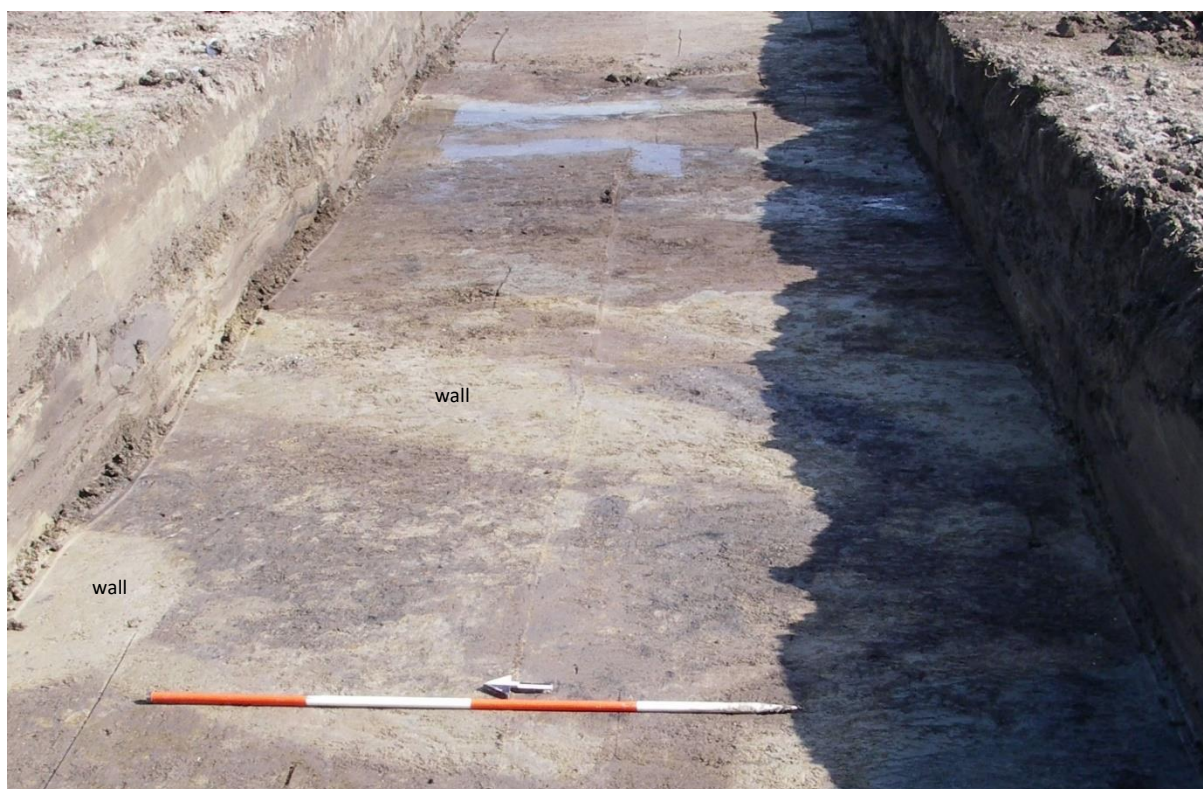
Fig. STR10-1. Trench 1, level 7, showing the two easternmost turf walls of structure 10.

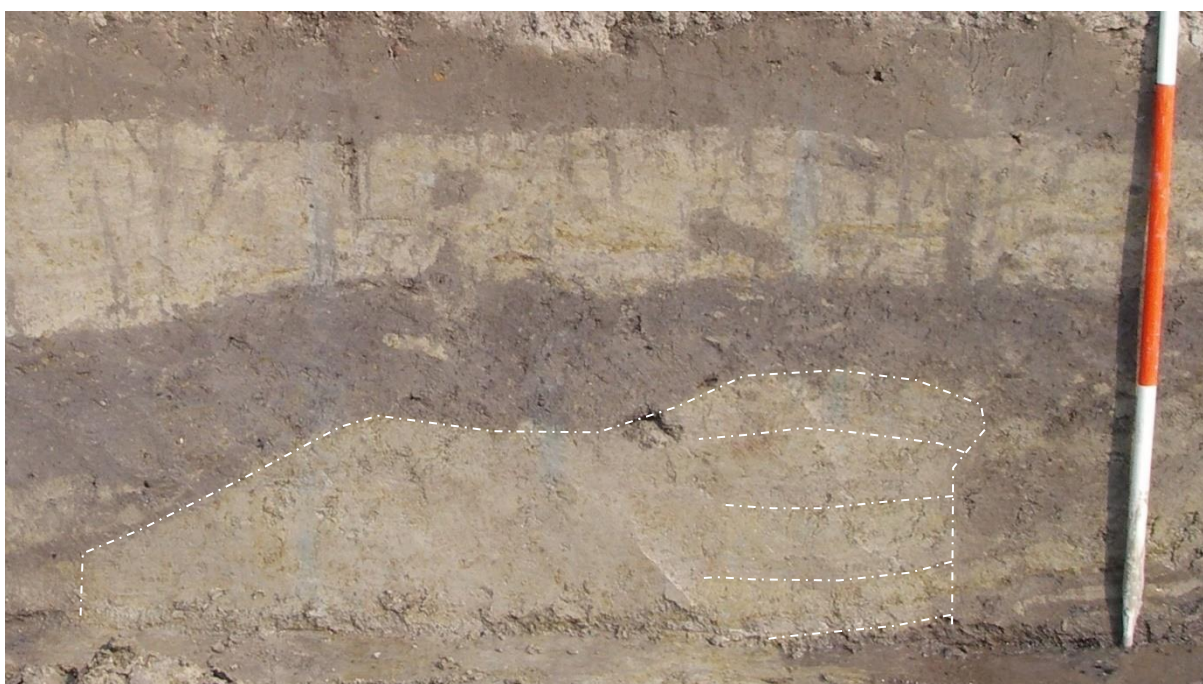
Fig. STR10-3. Detail of the middle turf wall (F917) in the north profile, showing the use of ca 11 cm thick turves.

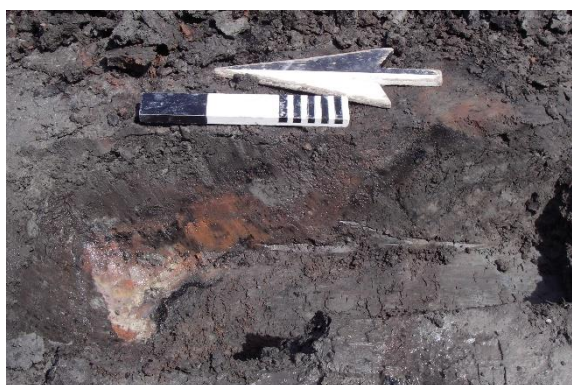
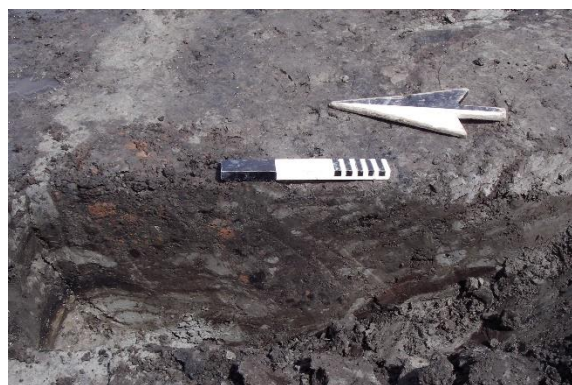
Fig. STR1-2. Sections through feature with burnt fill (left; T8 L9 F28) and north post (right; T8 L9 F29).

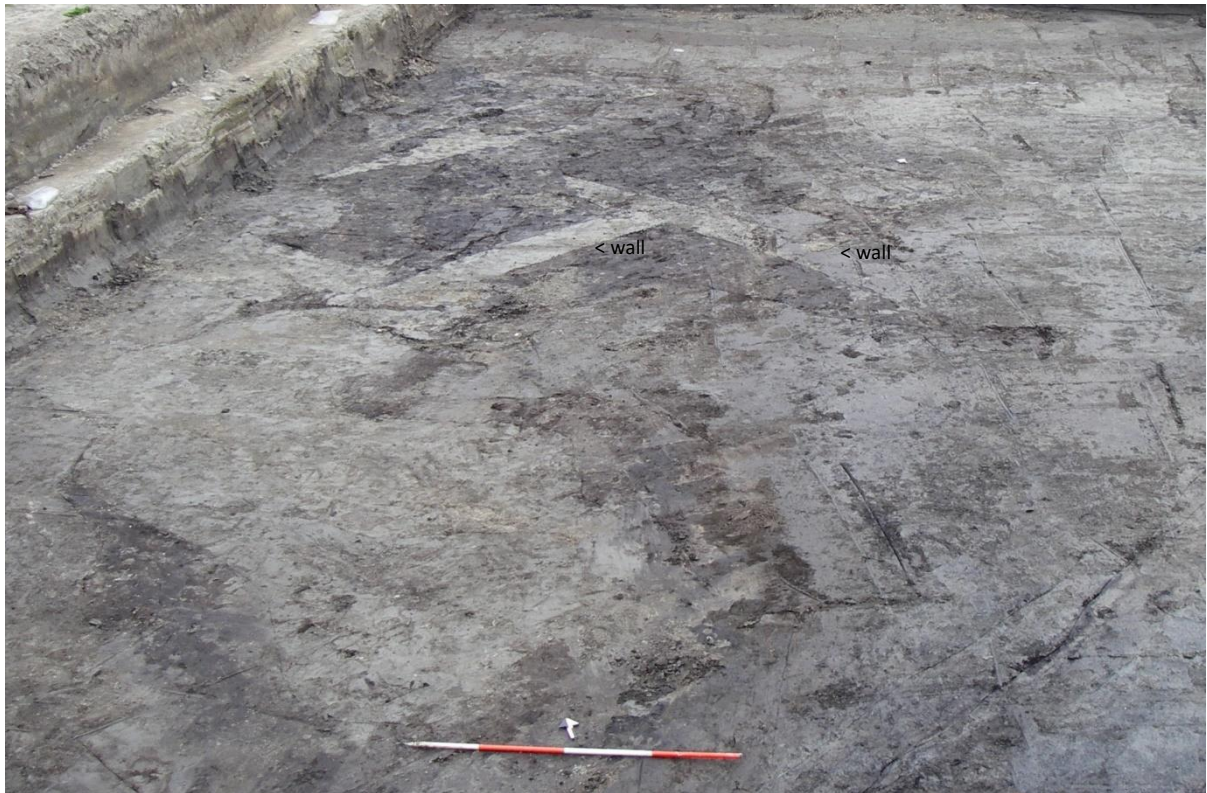
Fig. STR12-1. Trench 2, level 7, showing the northwest long wall (T2 L7 F336) and northeast short wall (T2 L7 F247).

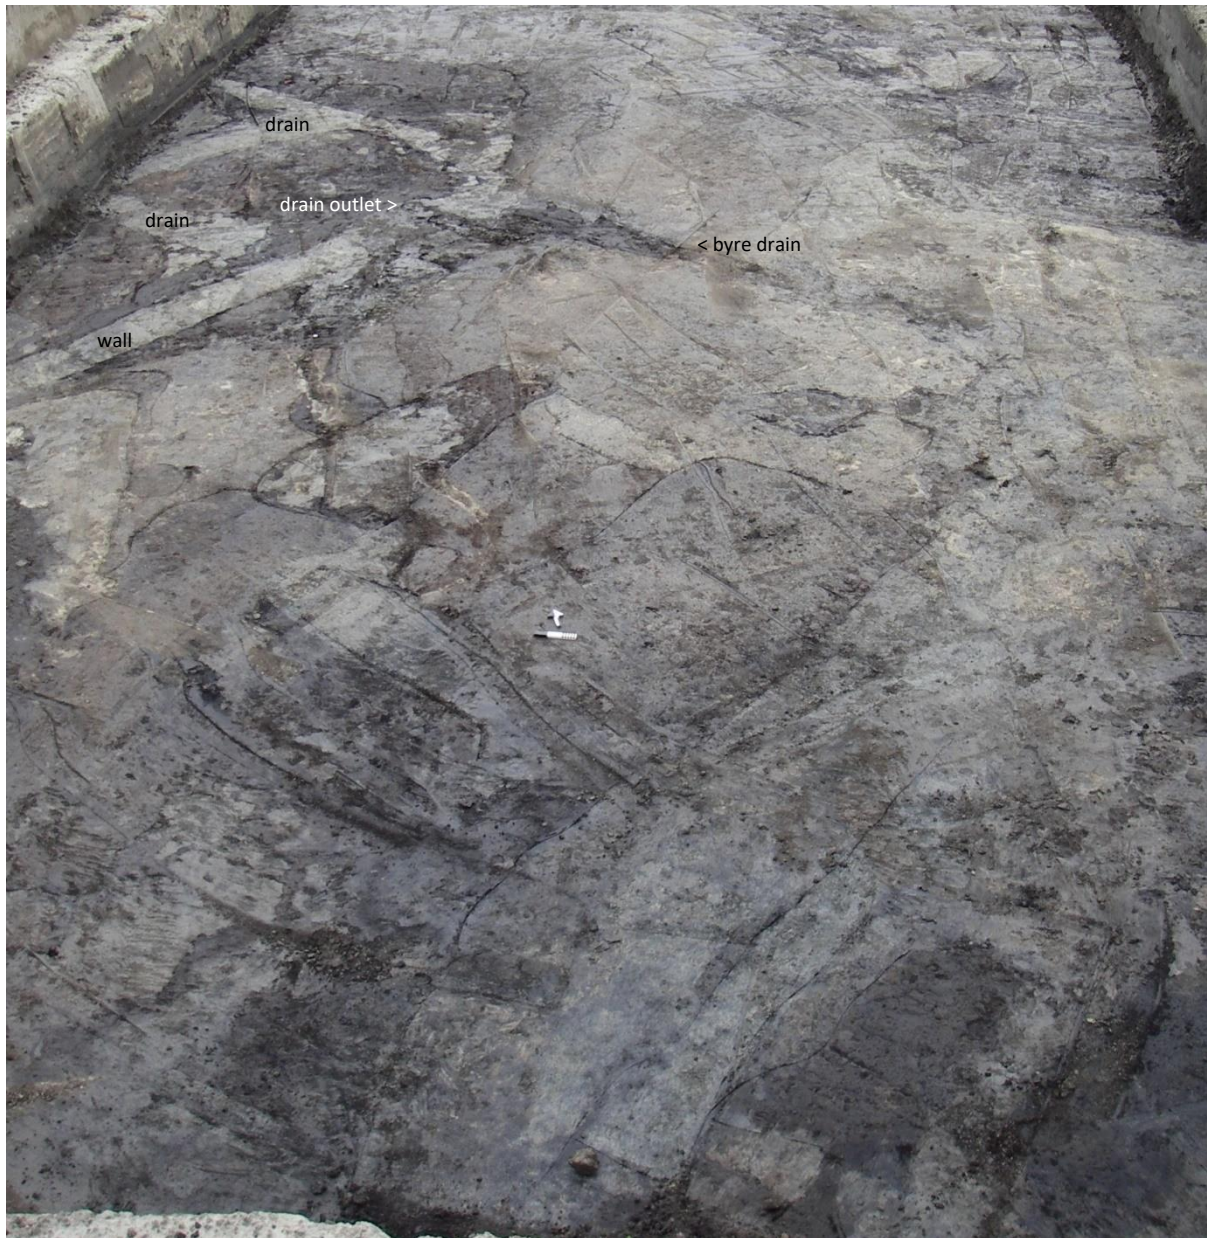
Fig. STR12-8. Trench 2, level 8, showing the lower courses of the northwest long wall (T2 L8 F336), the byre drain (T2 L8 F428/506) and turf-filled exterior ditches (T2 L8 F247/561).

5. Context: the byre drain emptied into a square at the north corner of the building, surrounded by ditches (T2 L8 F247, probably also T2 L8 F561; Fig. STR12-8). It is believed this arrangement was for the urine to seep out, until the manure could be used to heighten the settlement mound. A probable boundary ditch (T3 L8 F330) was noted southwest of the building. A rectangular feature measuring 3.2 x 2.4 m lay just outside the plot and is believed to have been the pit of a contemporary sunken feature building that was dug into the side northwest slope of the terp (compare structure 4), although this cannot be confirmed. The boundary ditch was moved northwest (T3 L7 F227) as the terp expanded. At that time, the presumed sunken feature building had gone out of use – replaced by structure 14?
A double inhumation was recorded within this latest perimeter of the extended plot. Its position as well as its orientation, parallel to the building's southwest short wall and the plot's northeast boundary ditch, suggest the grave was contemporary with this building.

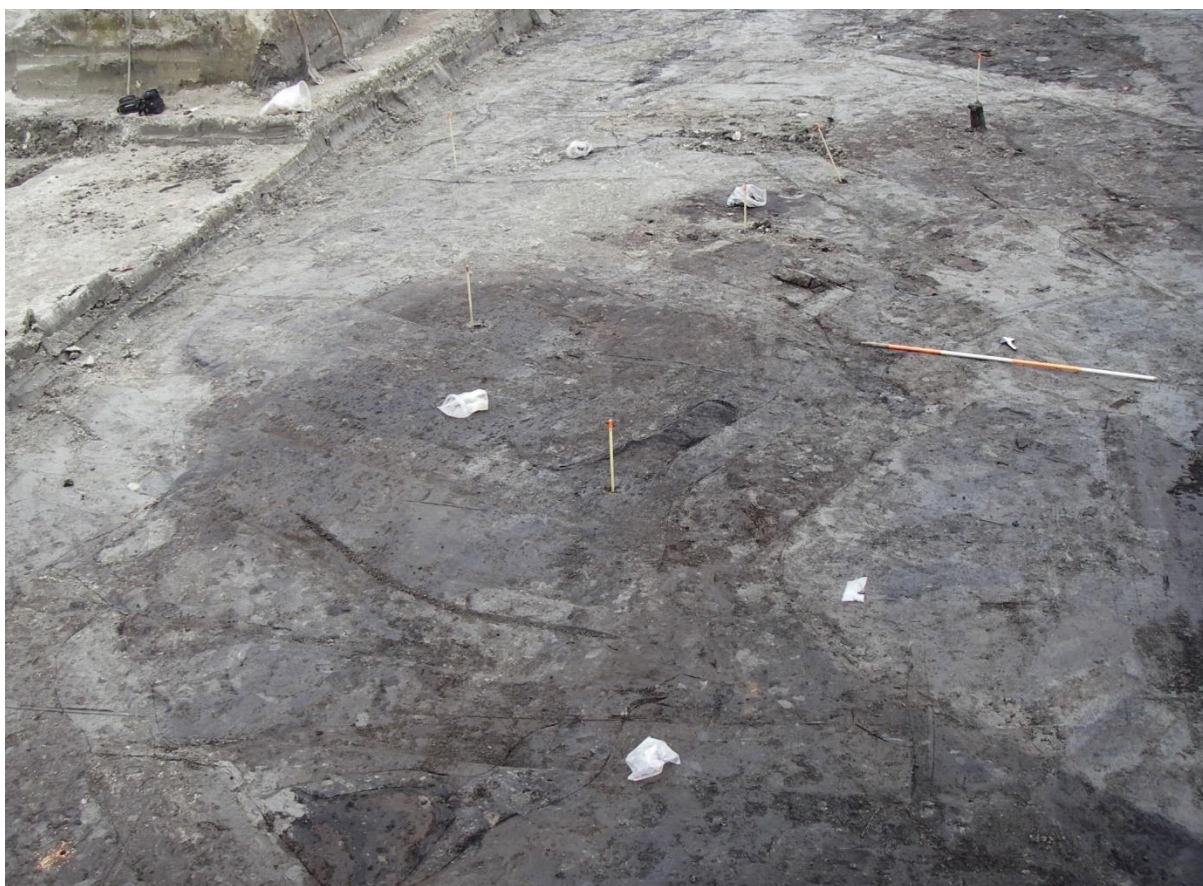
Fig. STR15-1. Trench 2, level 6, showing interior posts (marked with sticks) and the northeast short wall (T2 L5 F247).

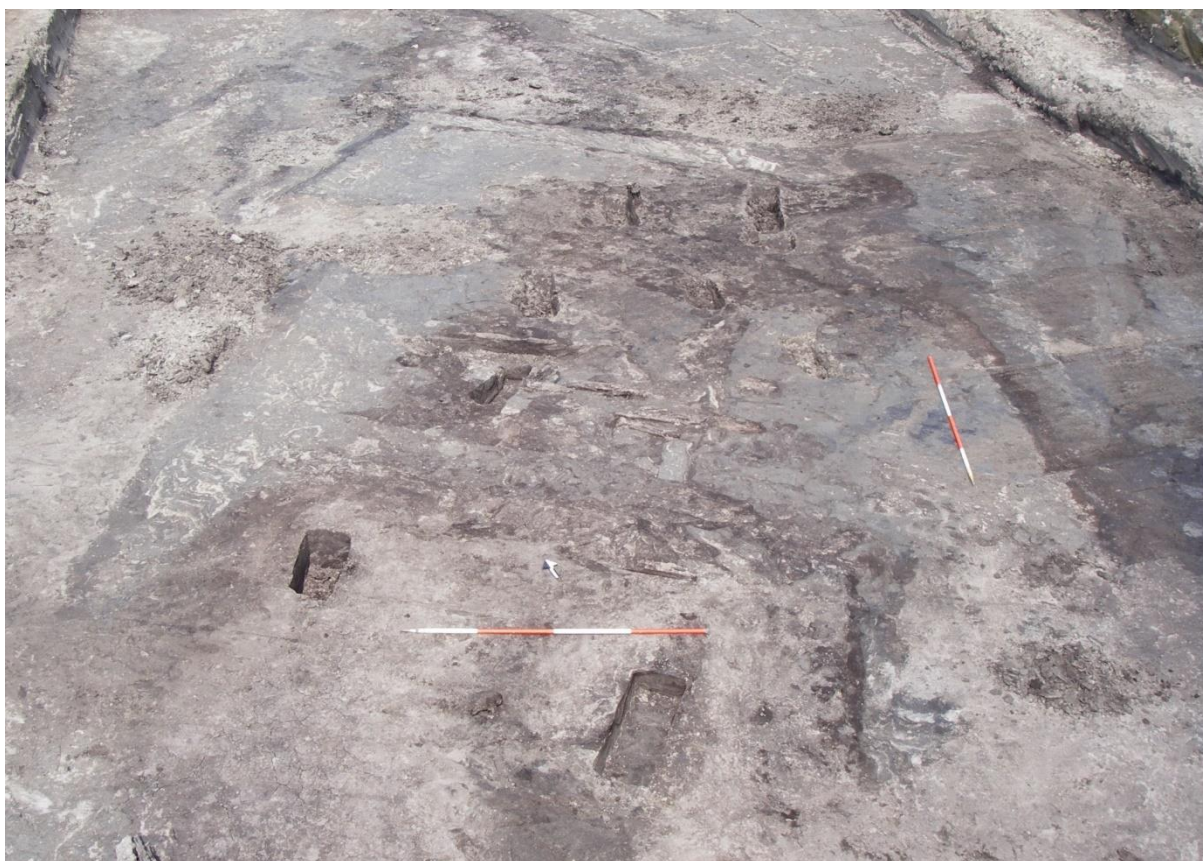
Fig. STR15-2. Trench 2, level 6, showing the northwest long wall (T2 L6 F373-374) and partition wall ditch (T2 L6 F254).

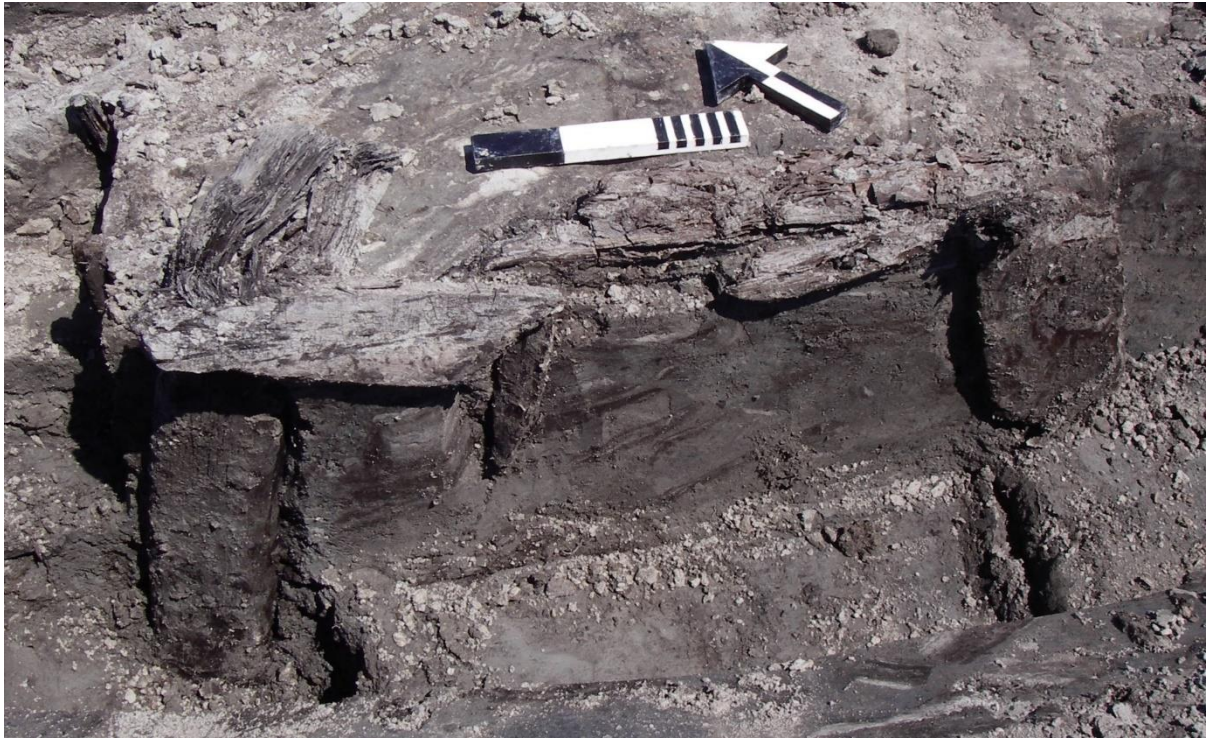
Fig. STR15-7. The horizontal timbers (T2 L6 F365, F367-368) attributed to structure 12 and a vertical post (left; T2 L6 F362) attributed to structure 15, at the southwest end of the middle aisle.

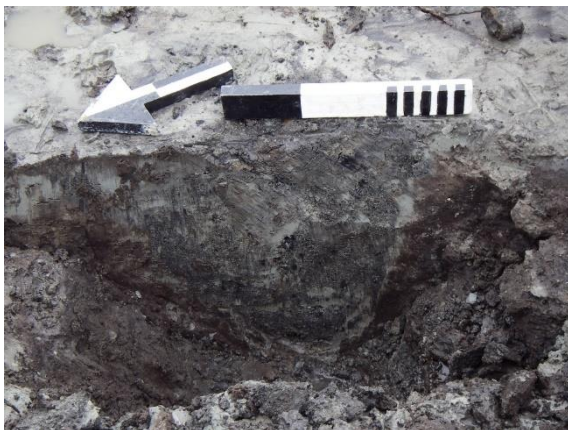
Fig. STR16-1. Section of the only confirmed post pit (T2 L4 F179).

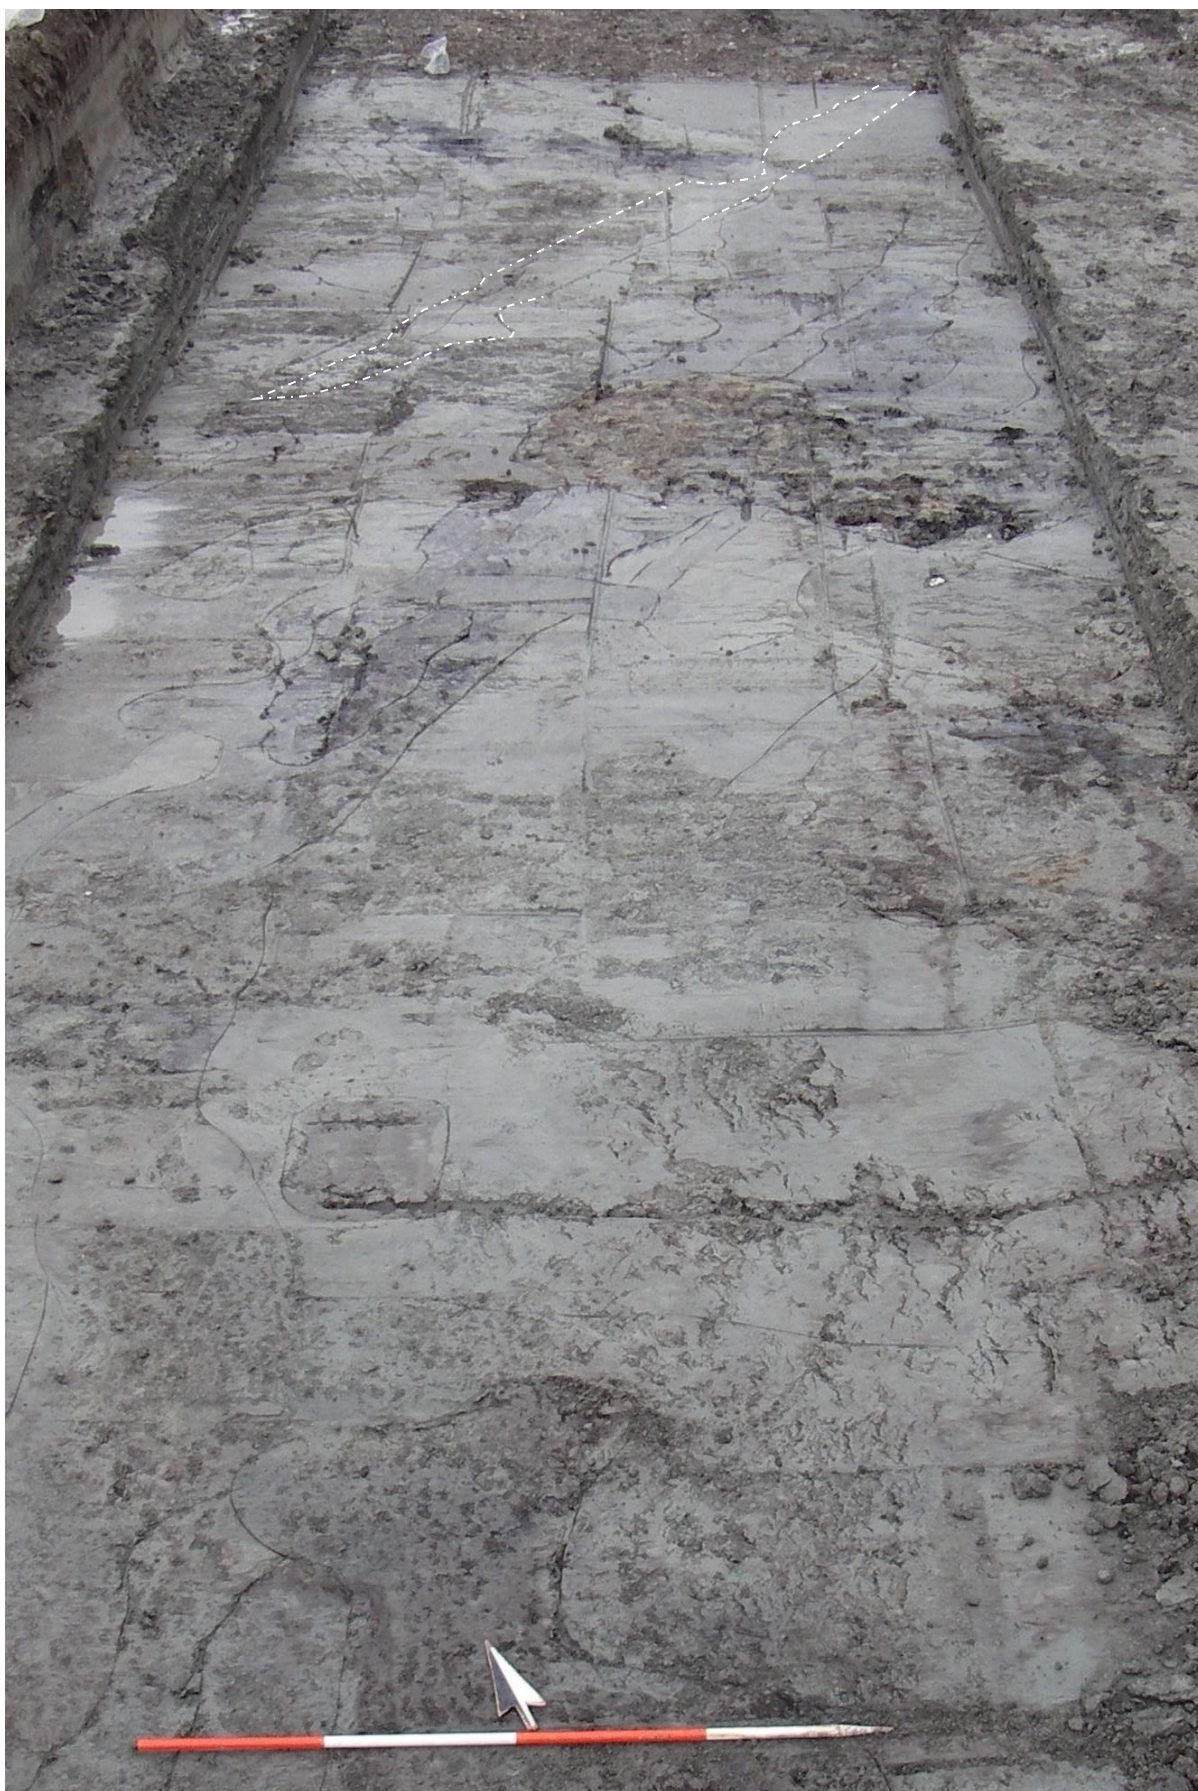
Fig. STR16-2. Trench 2, level 4, showing the latterly presumed wall ditch (T2 L4 F115). The suggested partition wall cannot be made out in the photograph.

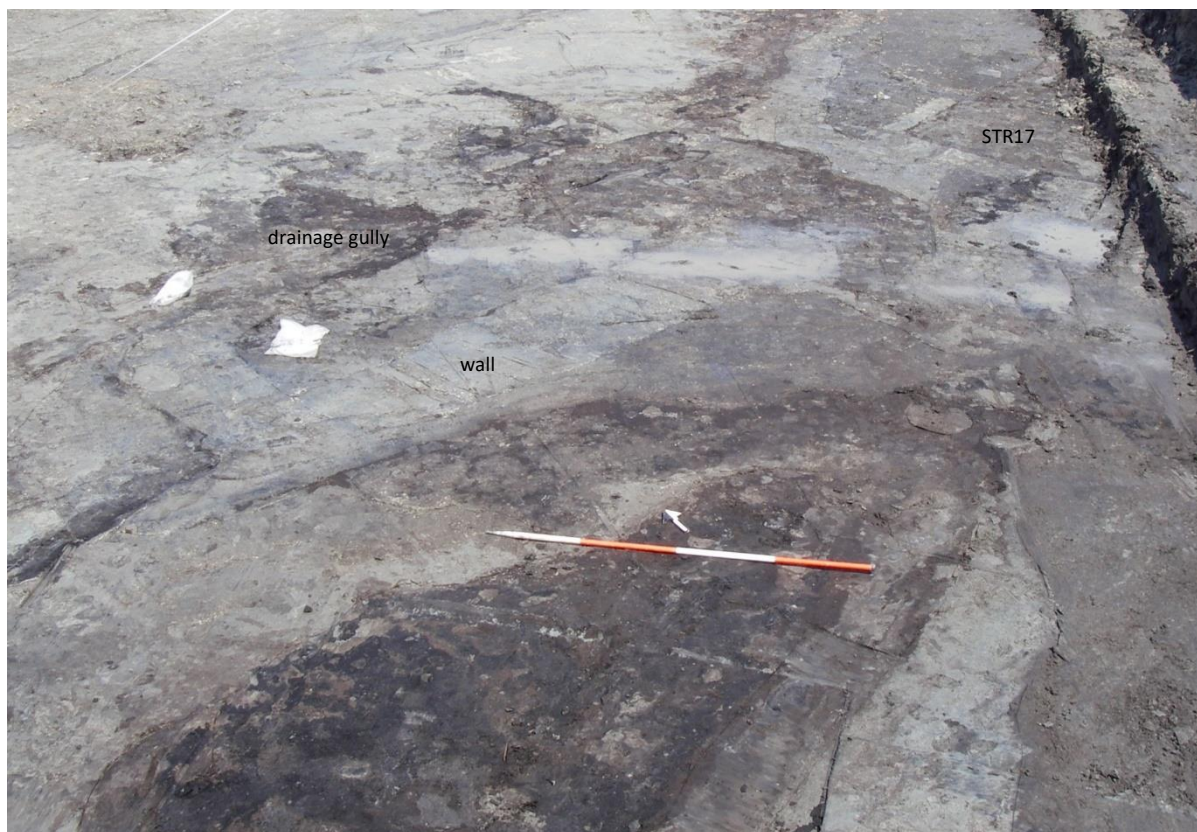
Fig. STR18-1. Trench 2, level 4, showing the lower (northwest) wall (T2 L4 F188) and adjacent drainage gully (T2 L4 F158). Structure 17 is visible in the background.

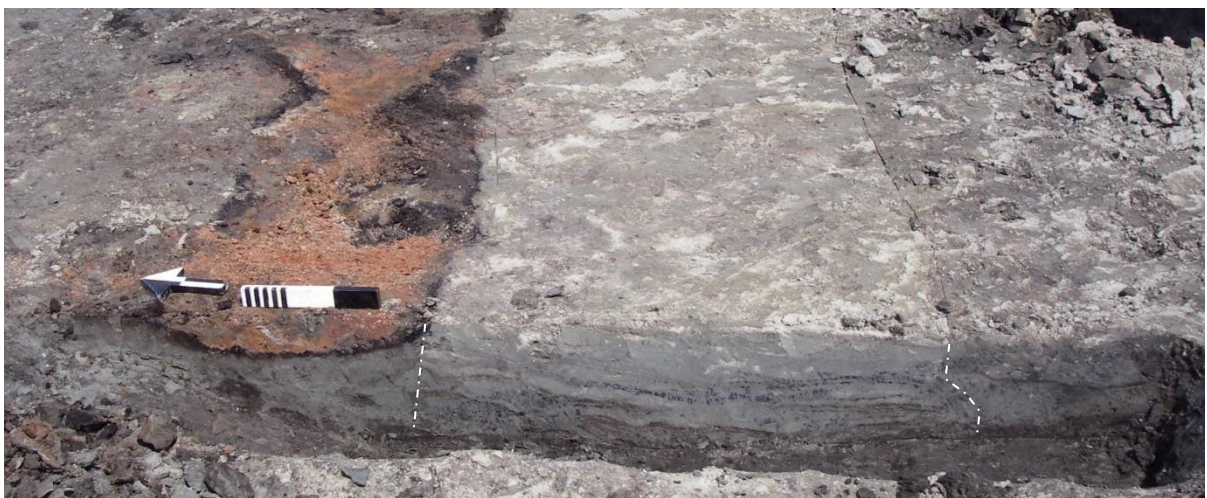
Fig. STR19-3. Section of the northwest wall (T2 L3 F97) and abutting burnt material (T2 L3 F106) and floor layers (right).
